# Case Studies in Risk Management Methods as a Component of the Remedial Process

Cecile Willert, P.Eng., QP<sub>RA</sub>  
January/February 2013

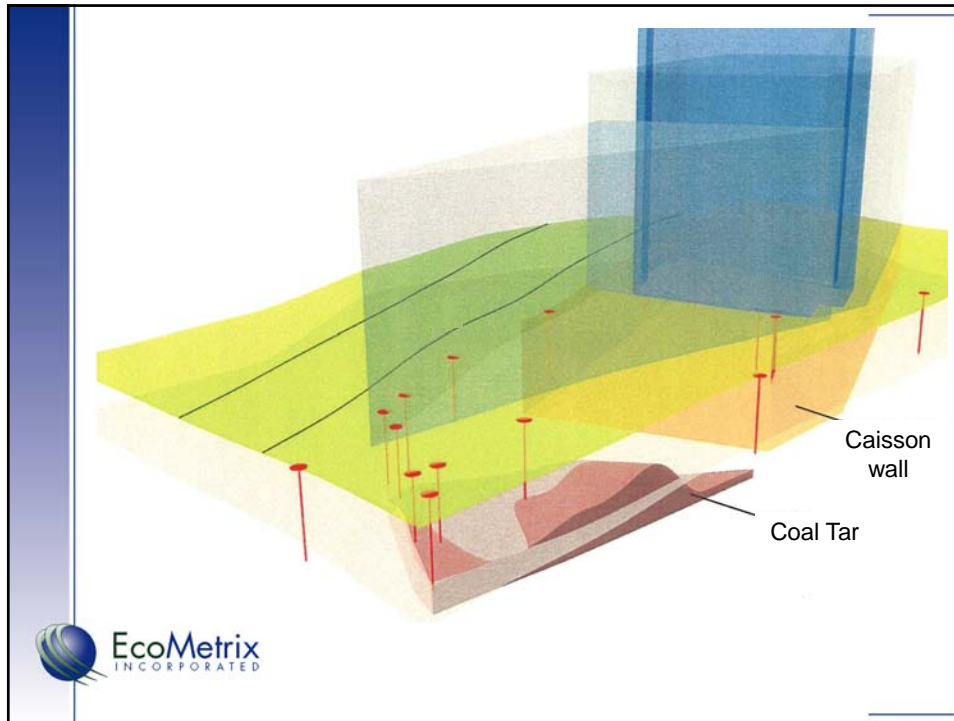
Outline of proposed parking garage

- Located underground parking to avoid DNAPL
- No subsurface structures above DNAPL (slab on grade)
  - minimize vapour intrusion & DNAPL/groundwater migration

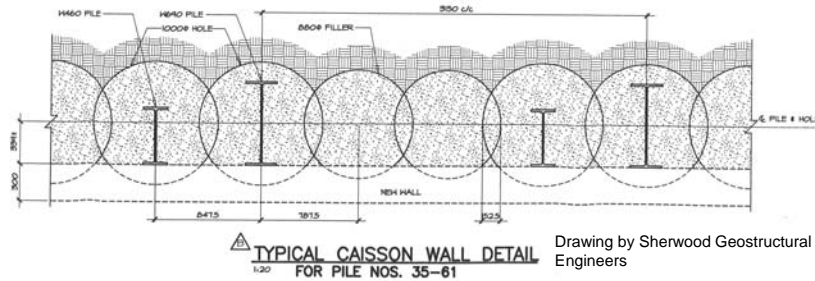
## Parking garage design

- Continuous caissons wall extended into sound bedrock
- Interior wall designed for hydrostatic pressure with drainage and bentofix layer
- Goal to prevent groundwater seepage into structure and collect and discharge any seepage
- Monitoring program to sampling drainage

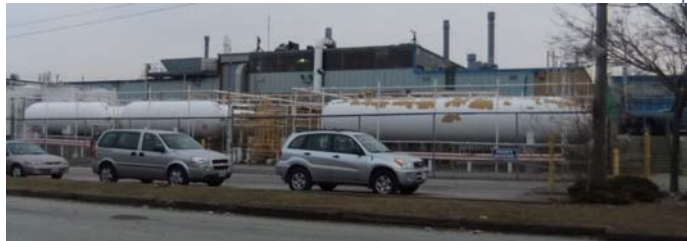
- Up-gradient tank farm – impacts evident
- Co-mingled plume providing carbon to fuel anaerobic degradation
- Building to remain, limiting remediation and risk management options
- Preliminary assessment conducted to scope risk management requirements
- Combine remediation with monitoring, plume migration controls and indoor air risk management

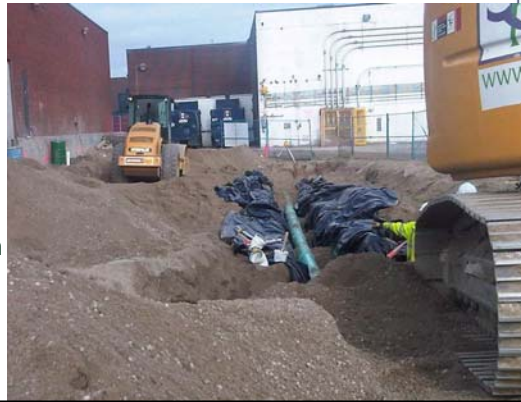
- Adjacent property cleaned to meet Table 3 standards
- Barrier wall installed to prevent direct migration off-site
- Remediation on-site limited due to building foundation
- Intermittent pump and treat system to prevent groundwater movement around barrier
- Repair and sealing of floor slab and foundation joints

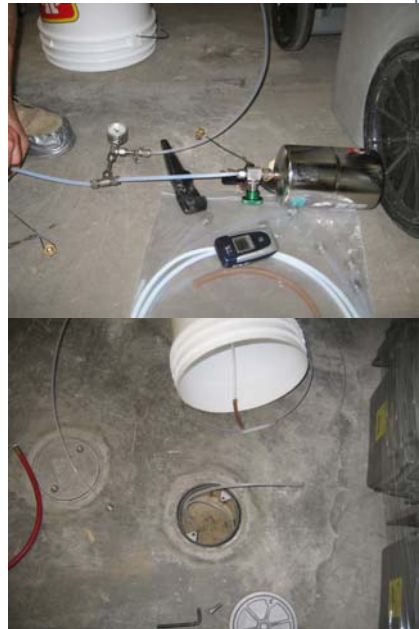
- Soil vapour monitoring conducted
- Risk assessment revisited based on results
- Soil vapour monitoring results well below criteria generated based on MGRA model

Photos courtesy of Conestoga Rovers
